Asbestos and Lead-Based Paint Survey Report

1510 Truxtun Ave.
Old Barracks M17
North Charleston, South Carolina

February 5, 2020
Terracon Project No. EN197470

Re: Asbestos and Lead-Based Paint Survey Report
Old Barracks M17
North Charleston, South Carolina
Terracon Project No. EN197470

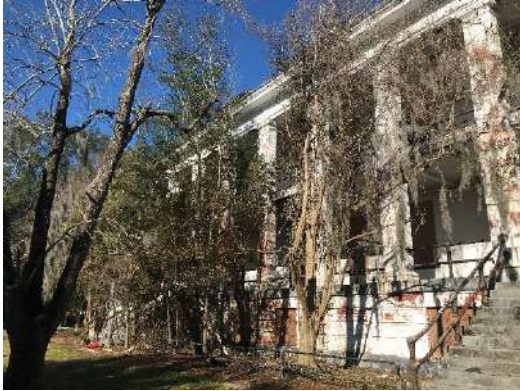
#1 View of Old Barrack M17

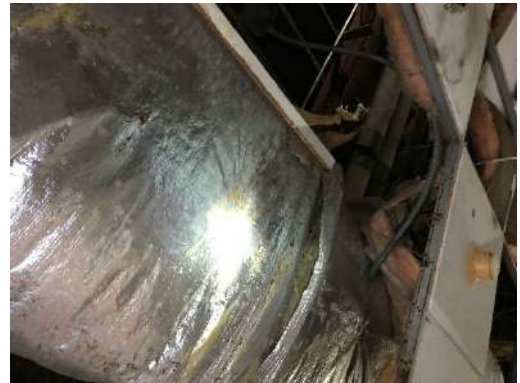
#2 View of HA-01 and HA-02: Pipe Mastic

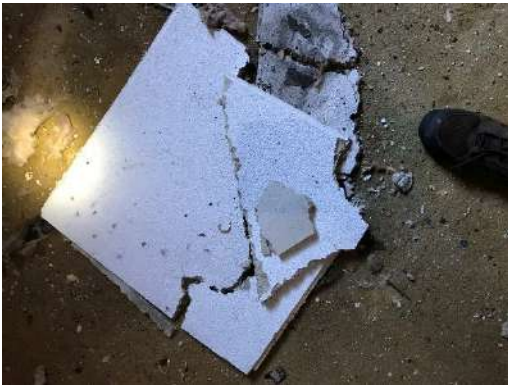
#3 View of HA-03: Ceiling Tile

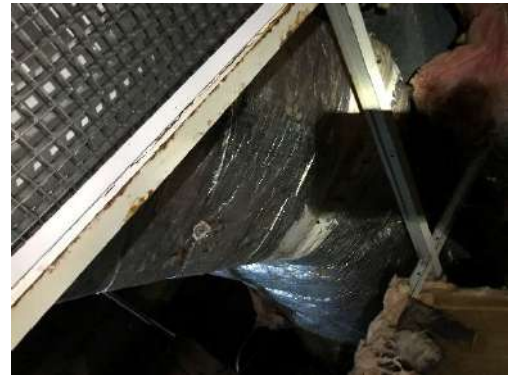
#4 View of HA-04 and HA-05: Duct Tape

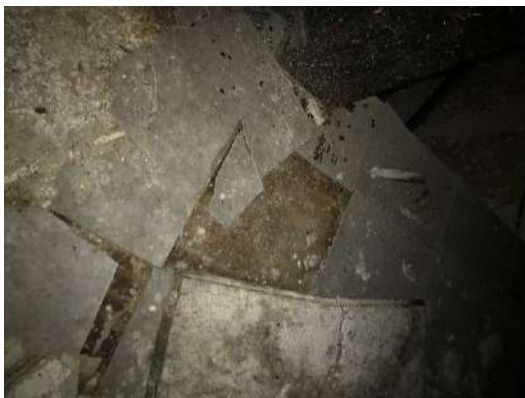
#5 View of HA-06 and HA-07: Floor Tile

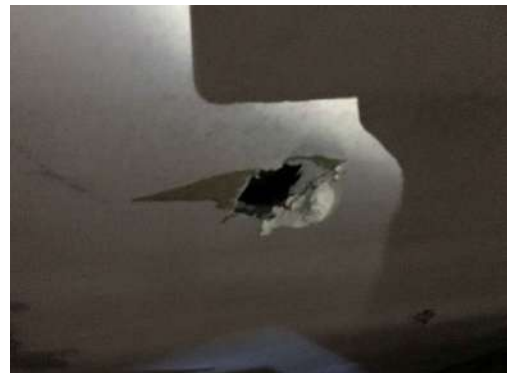
#6 View of Old HA-08 HA-09: DWJC

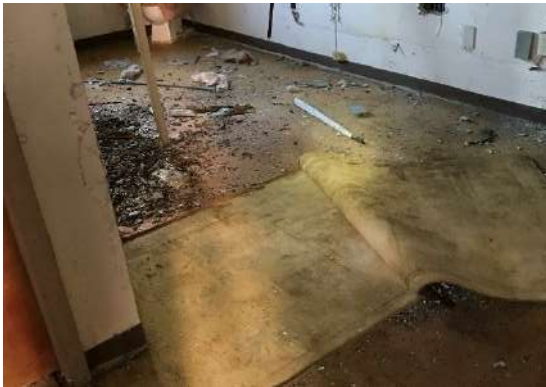
#7 View of HA-10: Carpet Mastic

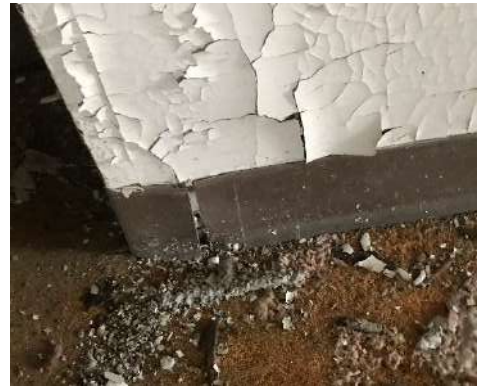
#8 View of HA-11 Base Mastic

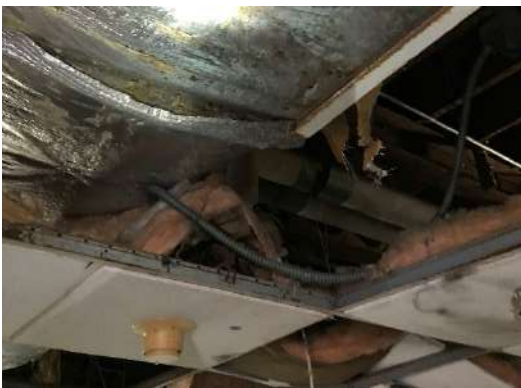
#9 View of HA-12, 13: Ceiling Tile & Duct

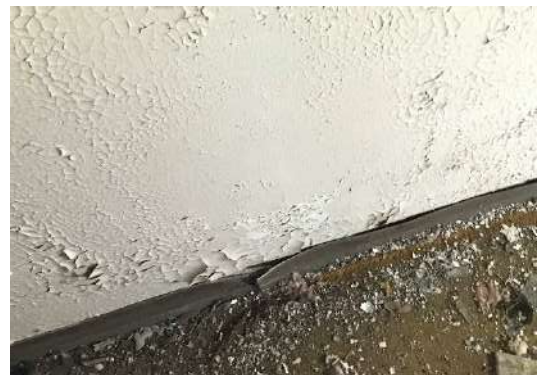
#10 View of HA-14: Carpet Mastic

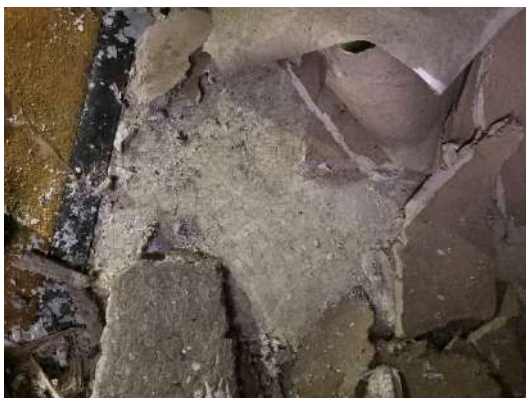
- Non-friable sheet flooring (10 % Chrysotile) associated with the bathrooms flooring located on the second floor. No mastic was observed in the laboratory analysis. If mastic is observed onsite, it should be assumed to contain asbestos.

#11 View of HA-15: Sheet Flooring

Terracon recommends removal of the asbestos-containing materials by a South Carolina licensed asbestos abatement contractor prior disturbance of these materials during renovation of the building. Additionally, third-party air monitoring is required during abatement since the aforementioned non-friable materials are damaged.

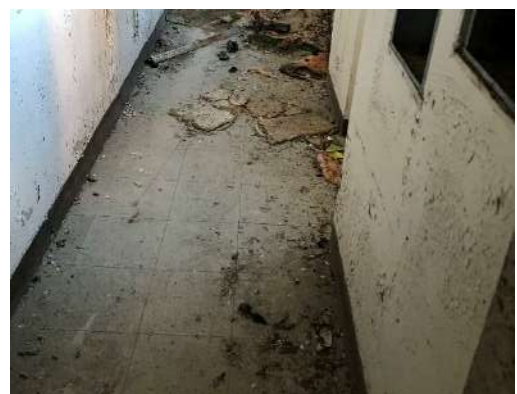
#12 View of HA-16, 17: Floor Tile & Mastic

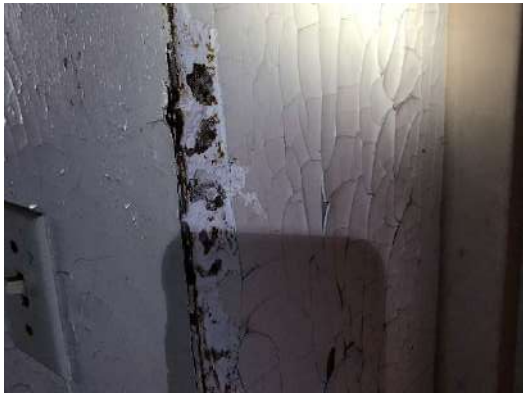
#13 View of HA-18,19: DWJC

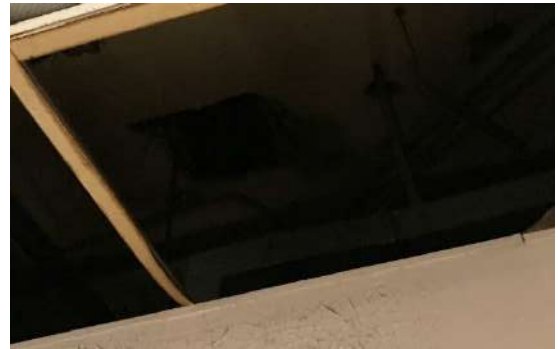
#14 View of HA-20 Wire-bound Plaster

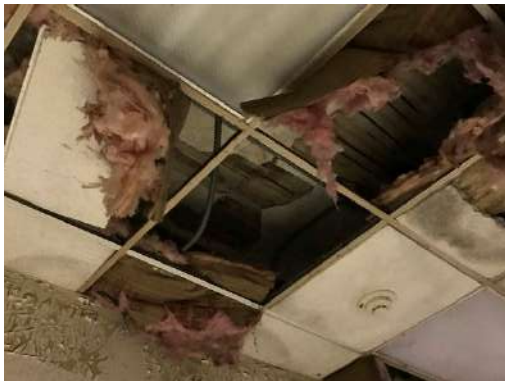
#15 View of HA-21: Wood-bound Plaster

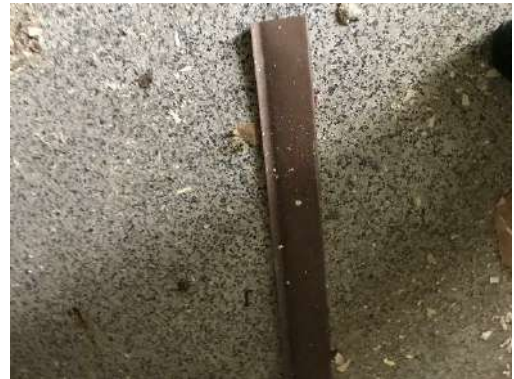
#16 View of HA-22,23: Cove Base & Mastic

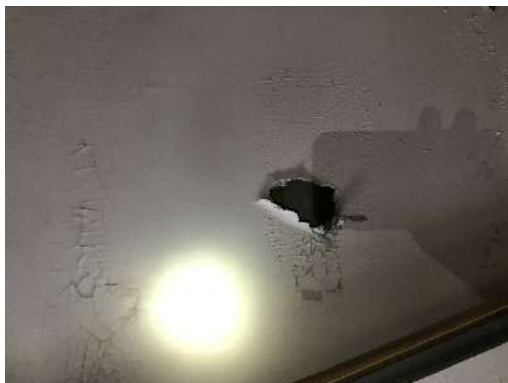
#17 View of HA-24,25: DWJC

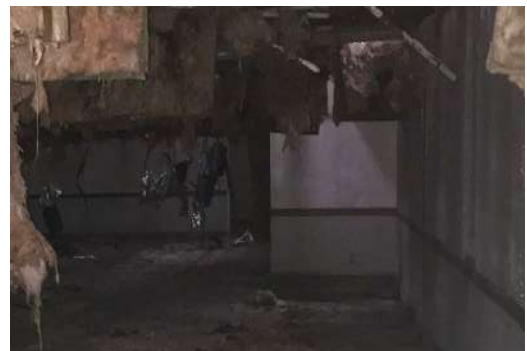
#18 View of HA-26,27: Door Gasket

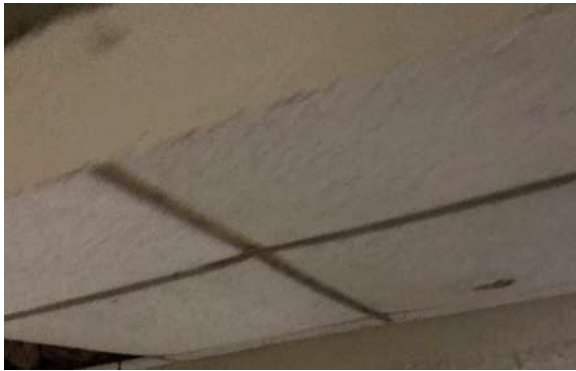
#25 View of HA-39: Ceiling Tile

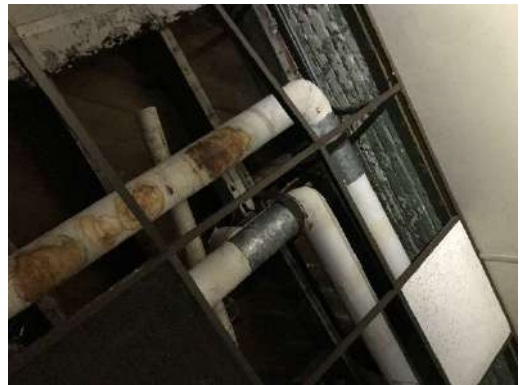
#26 View of HA-40 Pipe Mastic

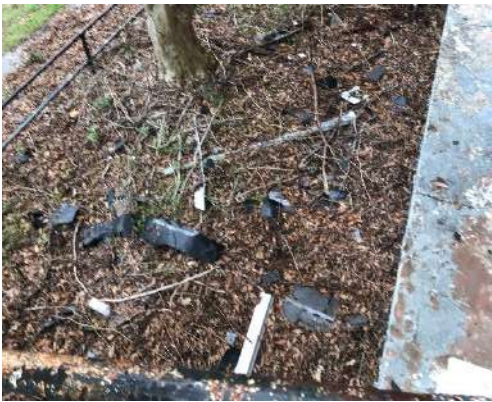
#27 View of HA-41,42: Roof Shingle & Felt
